### Internal Audit Unit

### Performance Audit on the Plant Operation and management on water supply Services

Reference: TT/IAU-4/2021-2022/000612 10/12/2021

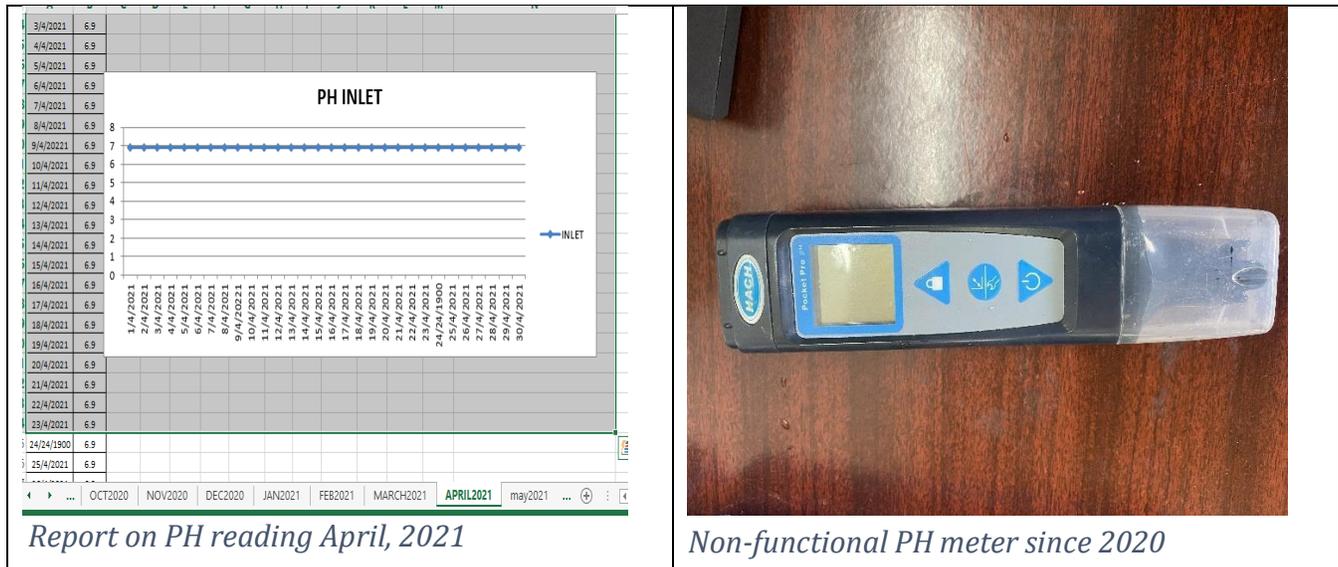
Dechencholling WTP, where the PH meter has been out of service since 2020 but daily readings are displayed in the report submitted to the IAU office until April 2021. Figure no 1

aid in the resolution of the water quality monitoring problem, as well as the development of our technician's competency.

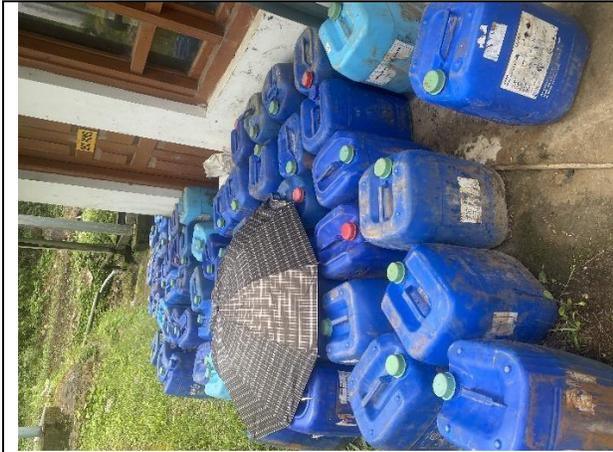
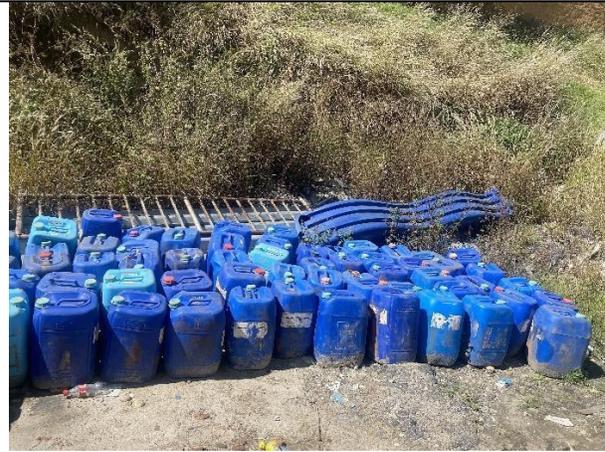
Figure No 2

With an objective to provide safe drinking water to the public, annually Thromde is spending Nu. 2 million (figure: expenditure statement for the financial year 2019-2020) for the procurement of water treatment chemical for the four water treatment plants. However, during the field visits, it was discovered that Thromde lacked sufficient and safe liquid chlorine storage. For instance, liquid chlorine jerry cans were kept outside at the Dechencholing water treatment plant and Thromde store (lungtenzampa) as shown in Figure no 2

*Location: Dechencholing WTP*

*Location: Lungtenzampa Store*

To guarantee optimal stability, liquid chlorine should be stored in a cold, dry, and well-ventilated area away from direct sunlight. Sodium hypochlorite, sometimes known as chlorine bleach, is a rather unstable form of chlorine. Chlorine loses some efficacy each year: it can lose up to 50% of its potency in 6 months and up to 90% in a year. The stability of chlorine is affected by how it is stored. When exposed to extremes of heat or cold, as well as direct sunshine, its disinfection capacity will rapidly deteriorate.

In this aspects, IAU is view that improper handling of chlorine will not serve the purpose.

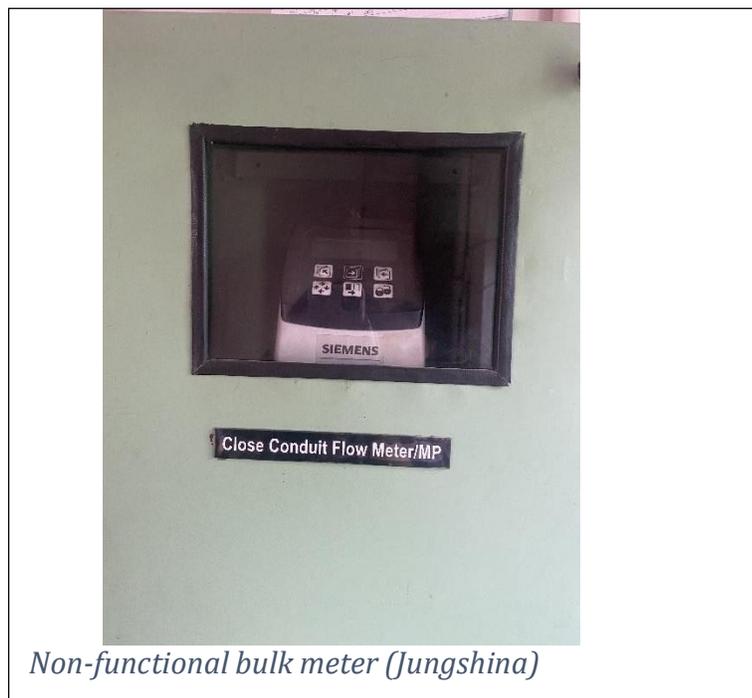
The bulk meters facilitate in calculating water revenue and water loss including non-revenue water. However, on site verification of water treatment plants, it was noted that the bulk meters at Motithang, and one bulk meter in Jungshina were not working and the production at Motithang and Jungshina were measured manually. What good is metering if it doesn't work? It's as good as not having one if the purpose isn't realized.

The non-functional bulk meters are presented in Figure No 3

Upgrade non-functional bulk water meter at production facilities so that the actual production records on the water is realized. This report will help in identifying the NRW similarly data will be accurate and can be used to develop the strategy plan for the decision maker.

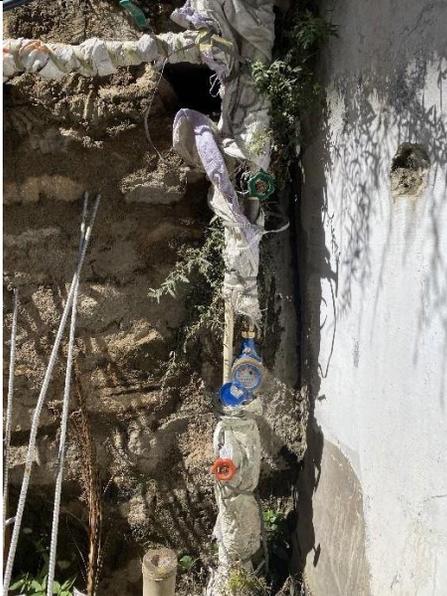
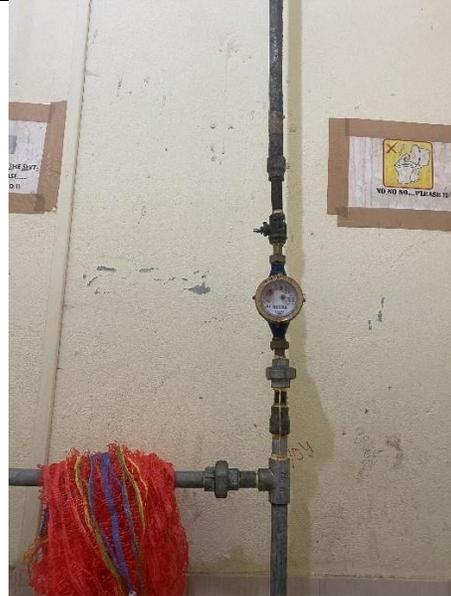
*Figure no 4: Vertical mounting of water meter*

Improper installations of water meters are mainly due to lack of guidelines and standards on water meter installation.

*location: Changzamtog*

*Location: Norzin (MKTS Building)*

- ✓ Aforementioned issues were raised due to a lack of guidelines for the water meter installation, getting it right from the beginning is one of best approach. Plumbers are currently installing water meters based on their knowledge and experience therefore, it is recommended to have one.
- ✓ Improper mounting/meter location should be rectify with working in collaboration with meter reader, and plumbing section in their respective zone.
- ✓ Regular consultative stakeholder meeting with the intra division; water meters, plumber, relevant engineer, concerned official needs to conducted.

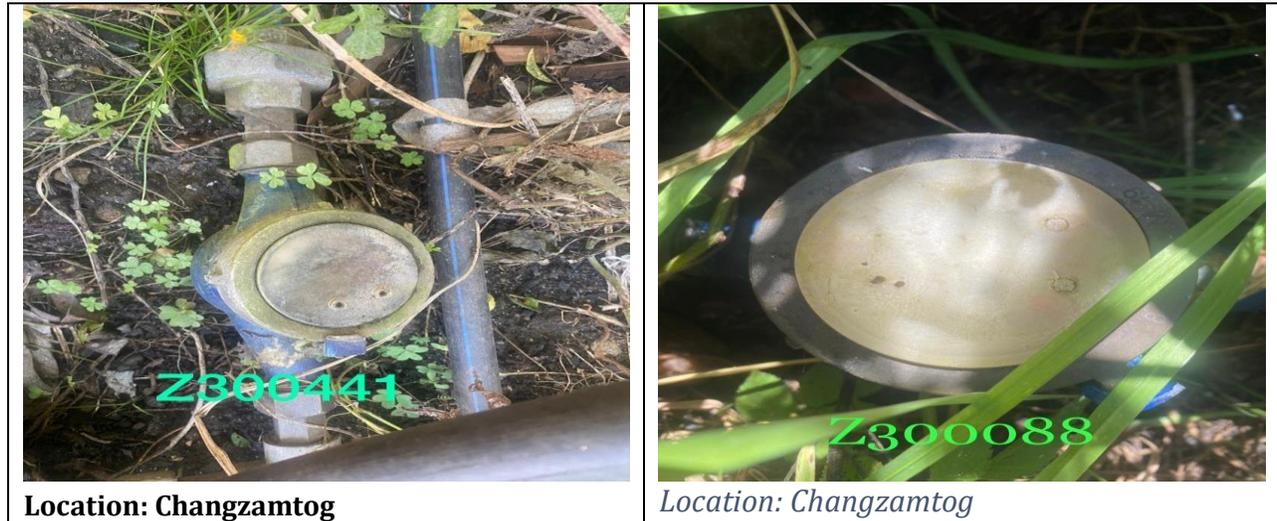
Figure No 5: Unclear water reading display

Such a situation is more likely to arise if dual reporting is not implemented; in this case, the water meter reader just informed the consumer and did not alert Thomde officials.

- ✓ Monthly defective water meter reports need to be compile and send it to the respective concern site engineer for work ratification. Such TAT must be developed. One of the reasons why people are reluctant to replace the water meter is that it is costly. Don't charge them all at once; adjust the from water bills from water bills until the meter cost is repaid.
- ✓ **Alert notification system** need to be integrated in the current system so that the information on the defective meter detected by the meter readers will be informed to concerned user and official for the rectification.

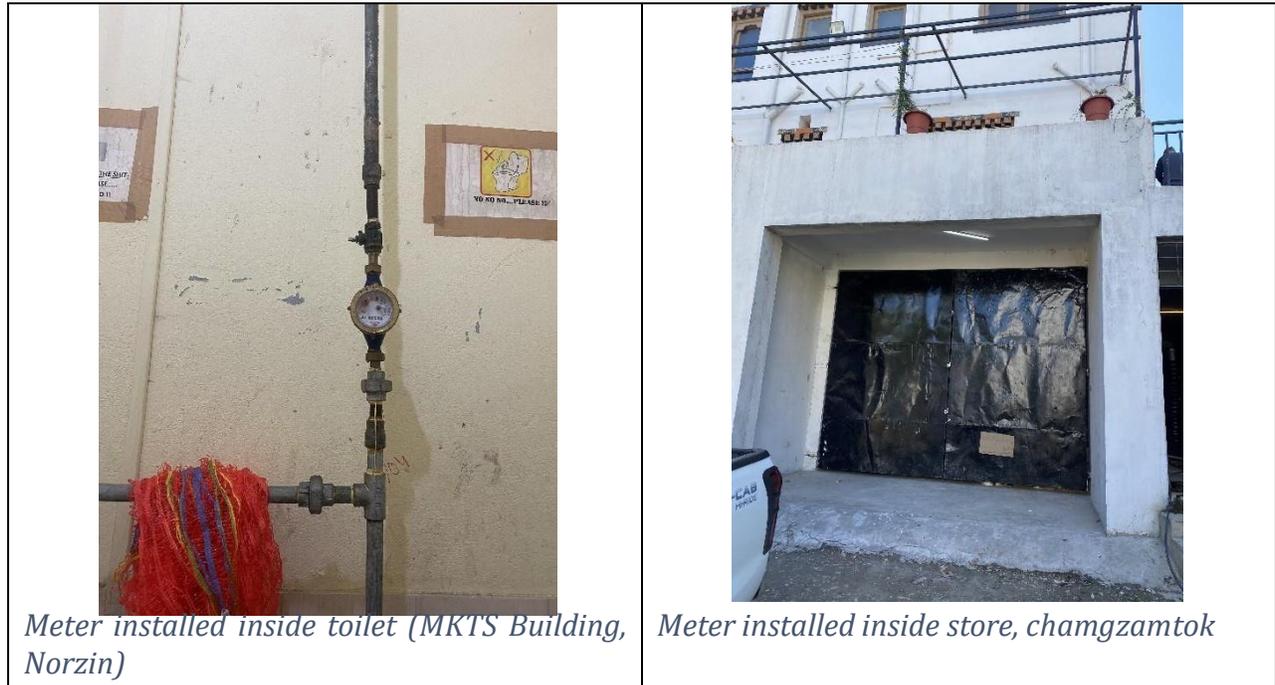
*Figure no 6: improper location of meter*

It is inappropriate to bill on the average consumption when the water meter is installed. Because average consumption may not reflect real usage, customers may be paid more or less as a result agency might be losing revenue as well as customer confidence on the system institute for the monitoring water consumption. When it's metered, the metering purpose should be accomplished. The problems are primarily due to a lack of guidelines and standards for water meter installation, as well as a lack of ToR and accountability.

*Meter installed inside toilet (MKTS Building, Norzin)*

*Meter installed inside store, chamgzamtok*

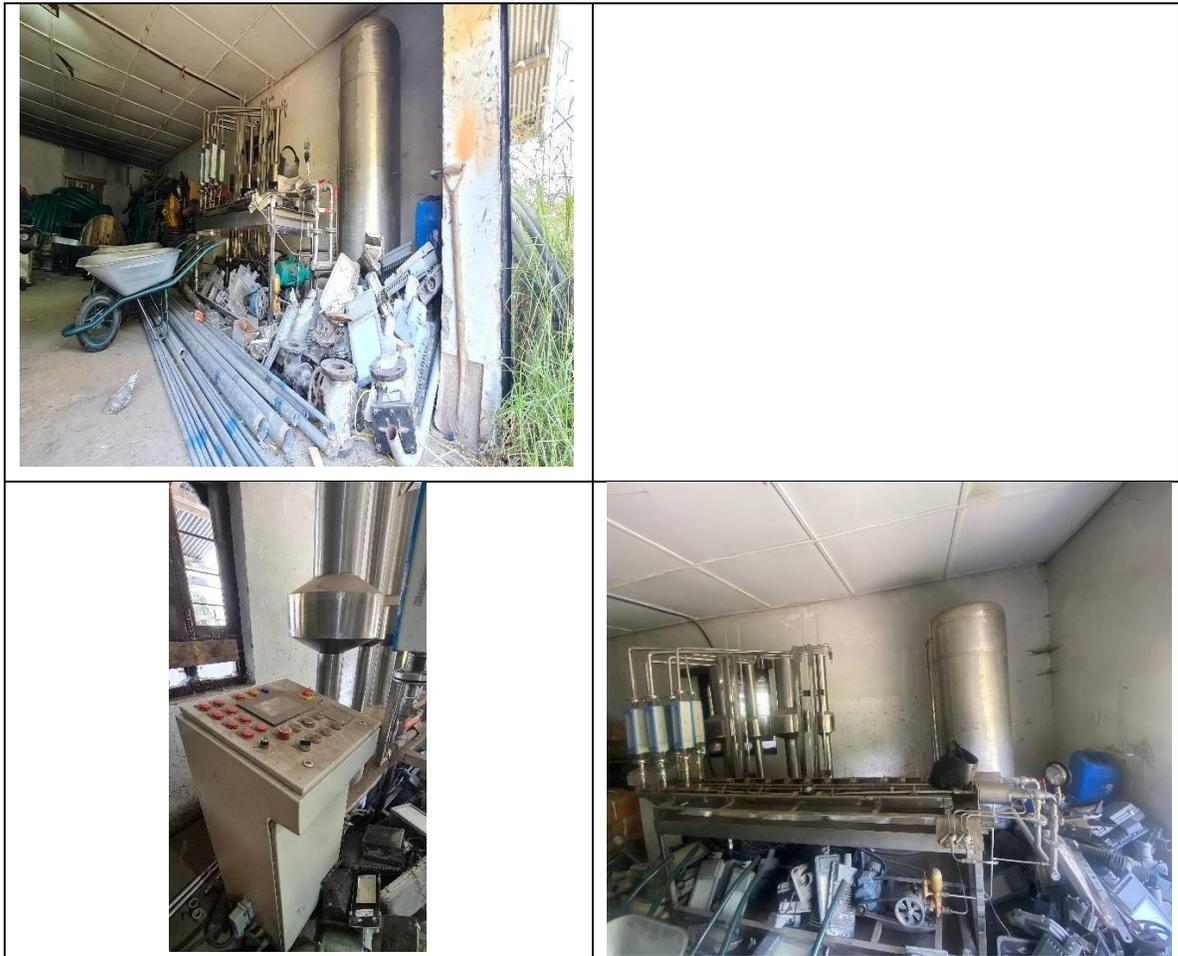
*Figure No 7: Water meter test bench*

The water meter testing bench is a necessary measuring instrument for water meter testing and repair in metrological services. In the year 2019, Thromde spent Nu. Twenty three lakh sixty eight thousand nine hundred eighty seven (23, 68, 987.00) on a water meter test bench. During the physical verification, it was discovered that the machine had been left idle for an extended period of time without being properly cared for, as illustrated in Figure 7.

The machine is not accounted for in either the asset management or the government inventory systems.
